# Manhole Inspection Summary

Manhole # S35II\_063MH

**Location** Address: **318 LANVALE ST**

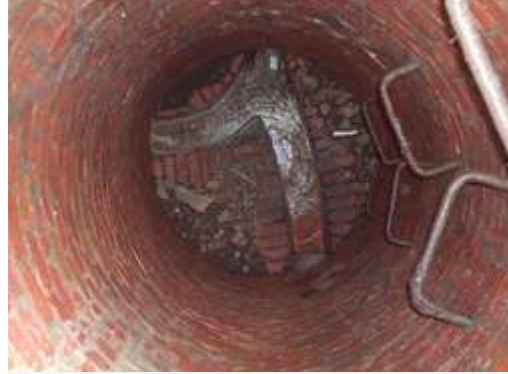
Top View

Corroded steps. Bench debris.

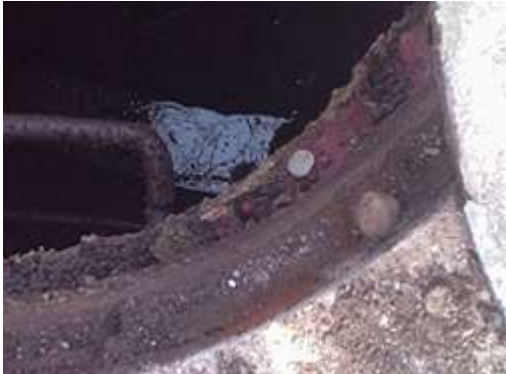
Defect

Frame offset.

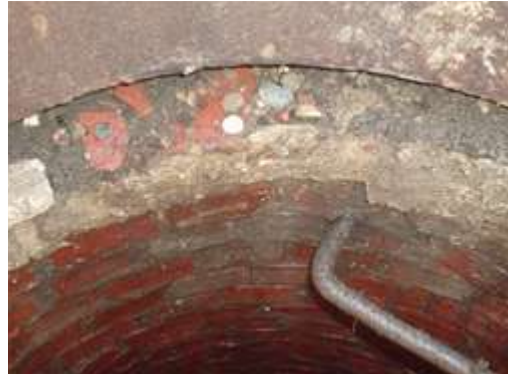
Defect

Frame leaks. Frame offset. Adjustment deterioration and infiltration.

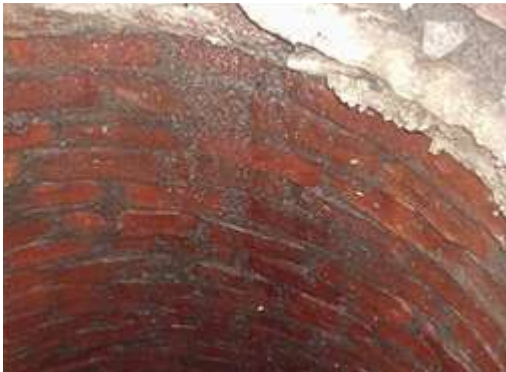
Defect

Adjustment deterioration and infiltration.  
Corbel infiltration.

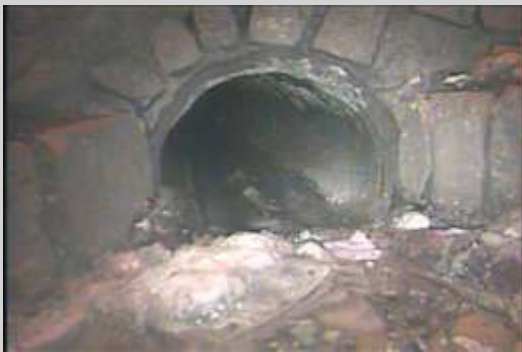
### 8 in. Circular Gravity Sewer Pipe Out @ 12 O'Clock

Deposits: ☐ None ☒ **Mud** ☐ Sludge ☒ **Debris** ☒ **Grease**

Silt Depth: **0.5** (in.) Deposits Extent: **Light**

Infiltration: **Evidence** Pipe Seal Cond: **Unknown**

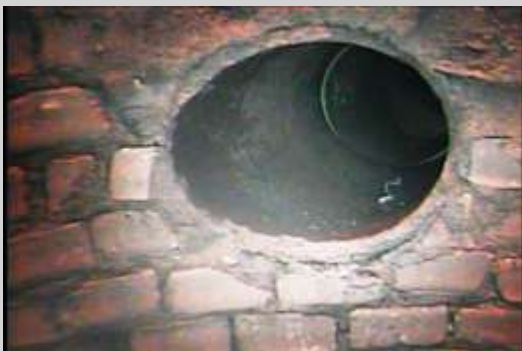
### 8 in. Circular Gravity Sewer Pipe In @ 6 O'Clock

Infiltration: **Evidence** Pipe Seal Cond: **Unknown**

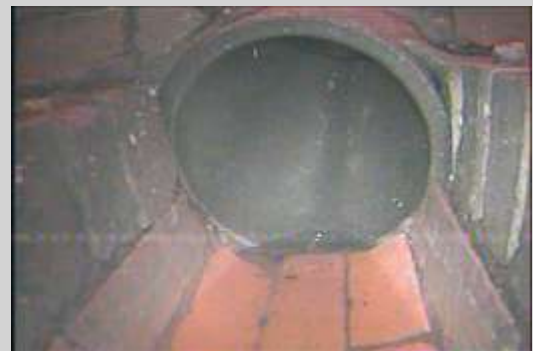
### Drop In @ 6 O'Clock

Channel deterioration.

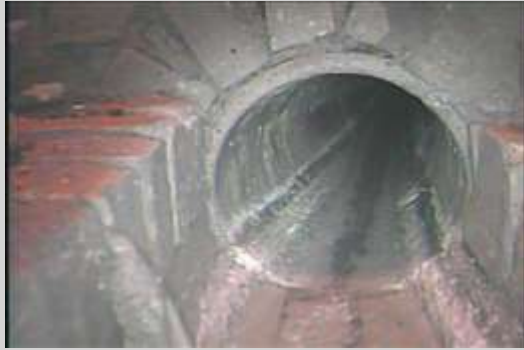
Pipe In @ 9 O'Clock

Deposits: ☐ None ☐ Mud ☐ Sludge ☐ Debris ☒ **Grease**

Deposits Extent: **Light**
